Tarco ROOFER'S REPORT

Self-Adhering Underlayment Holds Fast Against Wilma Mod Bit Protects While Tiles Blow Away

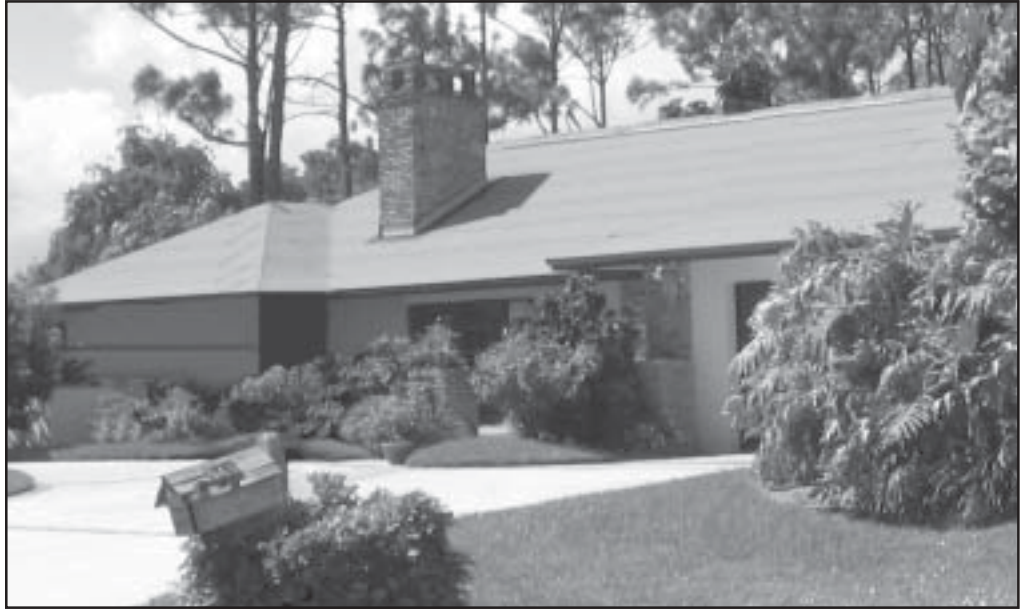
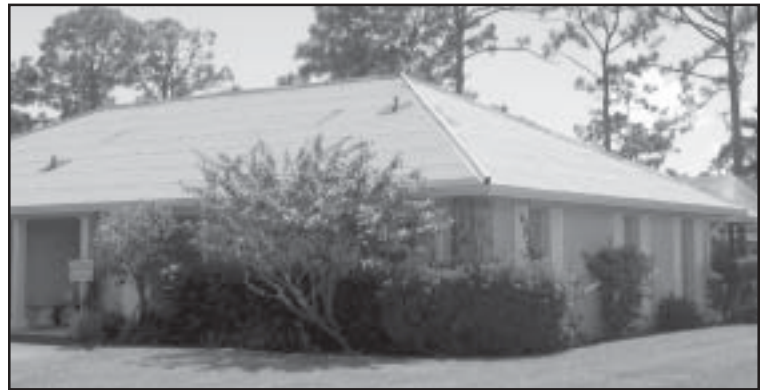
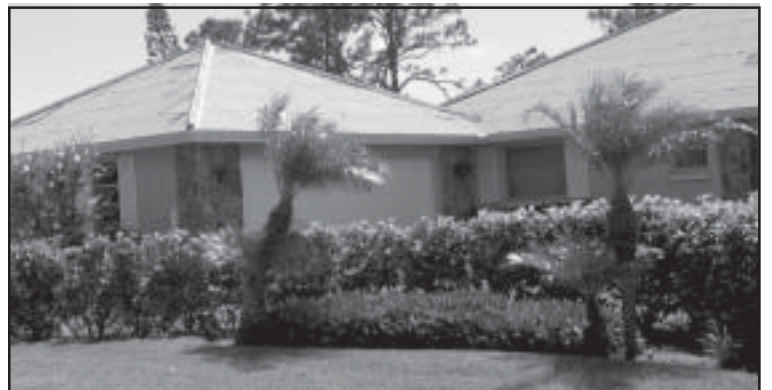
LeakBarrier Fast90 from Tarco survived the fury of Wilma when she passed through the Palm Beach area. Intended for use as a tile underlayment, Fast90 was serving as a primary roof for these residential homes because of delays in the delivery of tiles. (Photographs courtesy of Always Roofing, Lake Worth, Florida.)

Property destruction was widespread in the aftermath of Wilma. Smashed windows, downed power lines, ruined roofs and uprooted trees were everywhere. Yet the homes with Fast90 installed by Solomon survived Wilma's fury without damage to the underlayment itself, demonstrating that Fast90 can function temporarily as a primary roofing system, and also that it can provide outstanding protection against hurricane force winds – with or without tiles above.

Fast90 is a peel-and-stick product. Its bottom-side tackiness is the result of an SBS-modified asphalt coating that serves as both waterproofing agent and adhesive. It is not surprising that the self-adhering Fast90 membranes held tight as Wilma's winds blew past. Although strong winds can uplift tiles and even asphalt shingles, Fast90's "mod-bit" coating adheres tightly to the roof deck. The self-adhering selvedge along the side length of the underlayment is also coated with a peel-and-stick adhesive, which ensures there are no flaps of
